# Earthquake-proof racking: warehouse with Mecalux conventional racking on the Pacific Rim

The Mecalux racks installed in Warehouse 11 of Iron Mountain, a leading records management and archiving company, were the only ones which were able to withstand the 8.8 magnitude earthquake in 2010 that devastated the Chilean regions of Maule and Bio Bio. After the earthquake, Iron Mountain commissioned Mecalux to rebuild its many damaged buildings and to build two new warehouses with similar characteristics.

Country: **Chile** | Sector: **record & archive management**

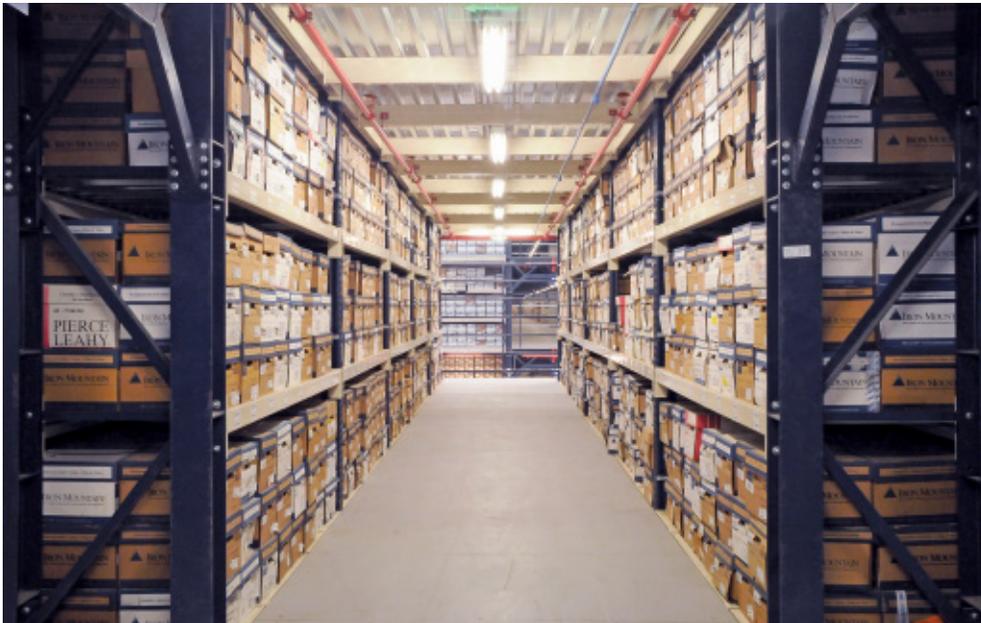
ual handling of the goods, is made up of tall, high-resistance racks with shelves at different levels on which the boxes containing the files are deposited.

Access to the various floors of the warehouse is performed by means of stairs, lifts and walkways.

Longitudinal rigid frames to reinforce the beams and columns on the four floors of the warehouse were also installed, along with the creation of a 4 m wide central aisle that enables comfortable handling of the load at the different locations. The central frames were fixed on a base plate calculated with sufficient thickness to provide maximum absorption of the shocks, since according to the calculations
